# Ubiquiti UniFi AP AC Lite TVS Diode Replacement

Repair an Ubiquiti UniFi AP AC Lite which is exhibiting a power fault problem: AP does not power on, and PoE Injector is blinking white.

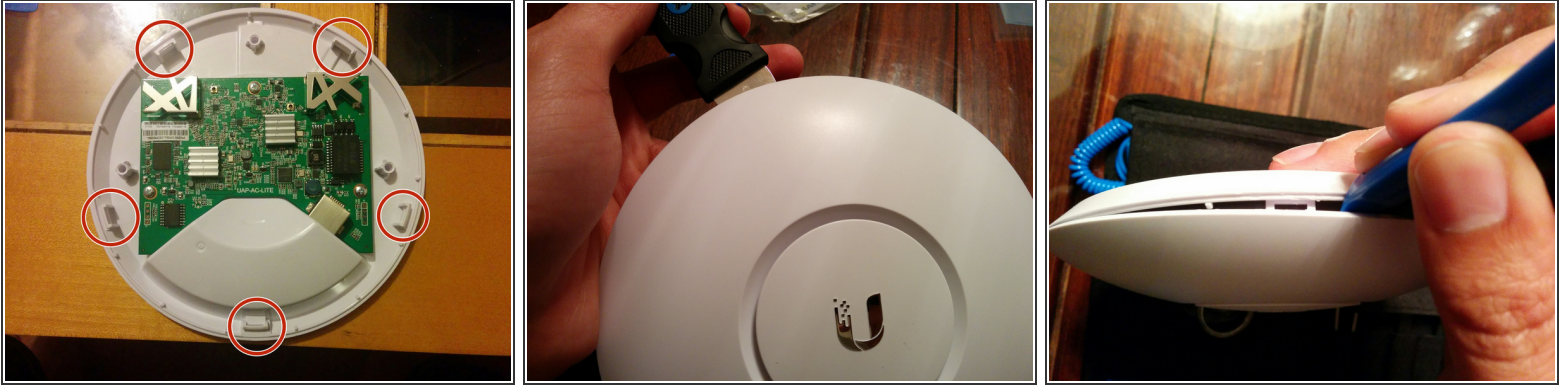
## Step 1 — Open the UAP-AC-LITE

- The front cover is secured by 5 tabs.
- Work the Jimmy into the space near a clip, and create a big enough gap to insert a prying tool. Moderate pressure from a prying tool should force the clips open.
- There are a number of alignment tabs that can get in the way. It is best to try and work the Jimmy towards the center of the front cover, hugging its inside surface.
- The PCB is held down by 3 screws. It is not necessary to remove the board for this repair.
